Subject: Annual Inspection Report
St. Elmo Airport

ANNUAL INSPECTION REPORT

ST ELMO MUNICIPAL AIRPORT

ST ELMO, ALABAMA

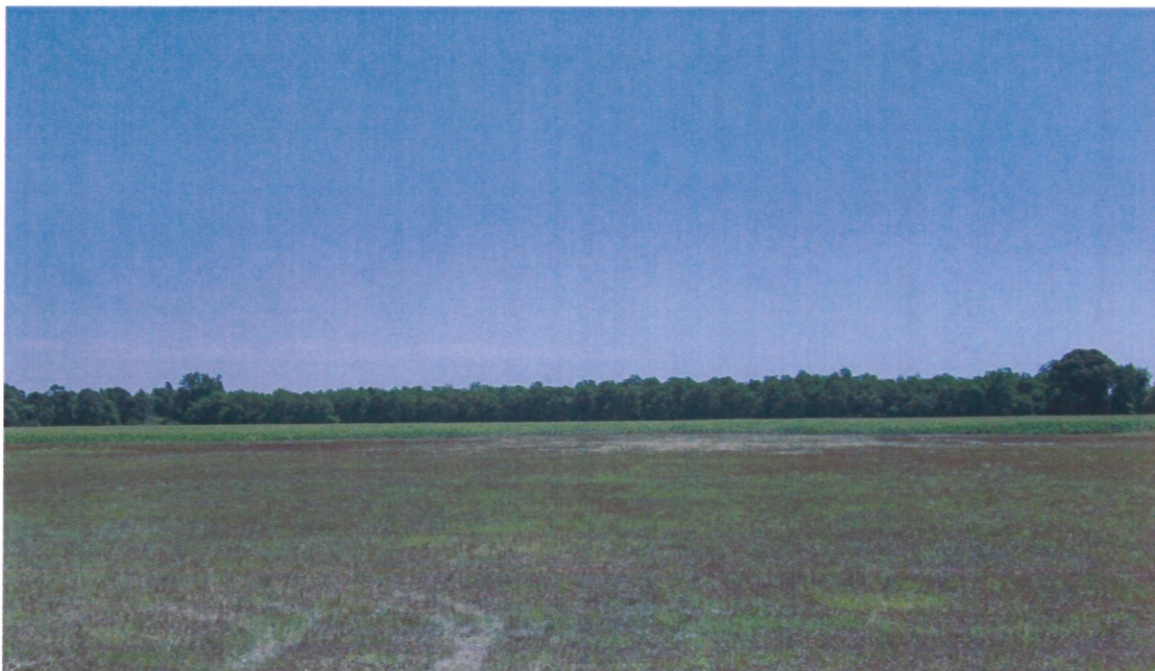
Photo # 1 – Runway 24 Approach

- Runway 24 – No obstructions (See Photo # 1).
- Runway 06 – No obstructions (See Photo # 2).

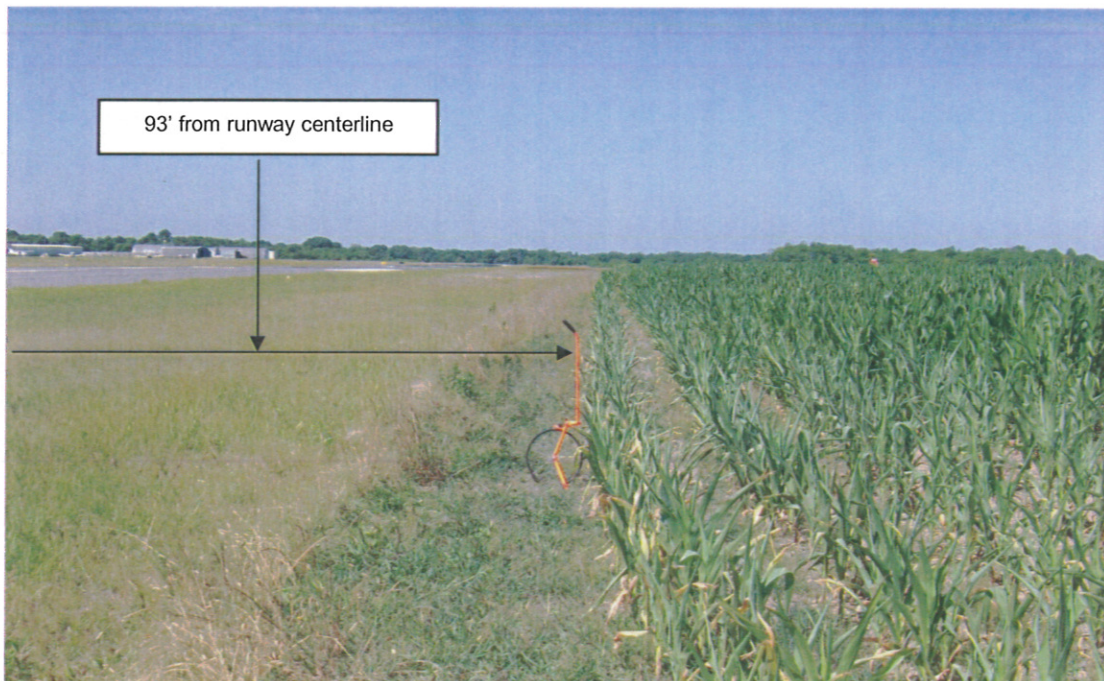
Photo # 3 – Primary Surface

- Farming activity is encroaching on the primary surface along the northeast side of the runway (See Photo # 3).

- Primary surface must be restored to 125 feet beyond runway centerline and farming activities limited to those boundaries.

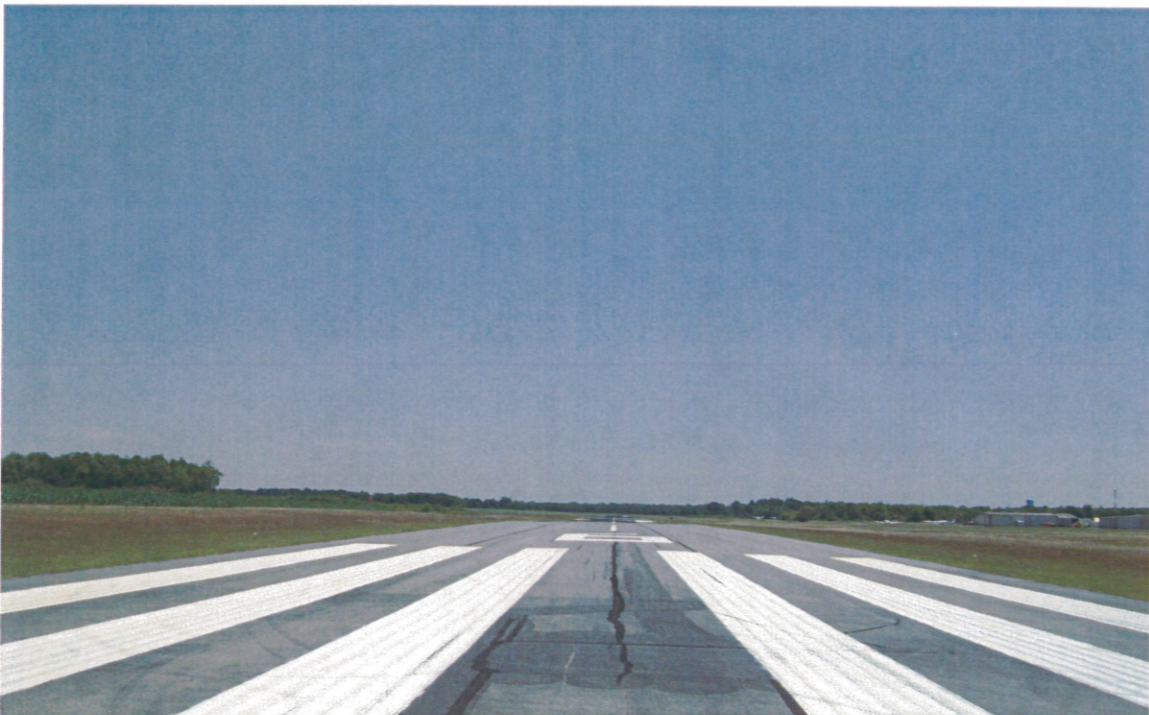
Photo # 5 – NPI Markings Rwy 6

- The airport markings are in good condition (See Photo # 5).

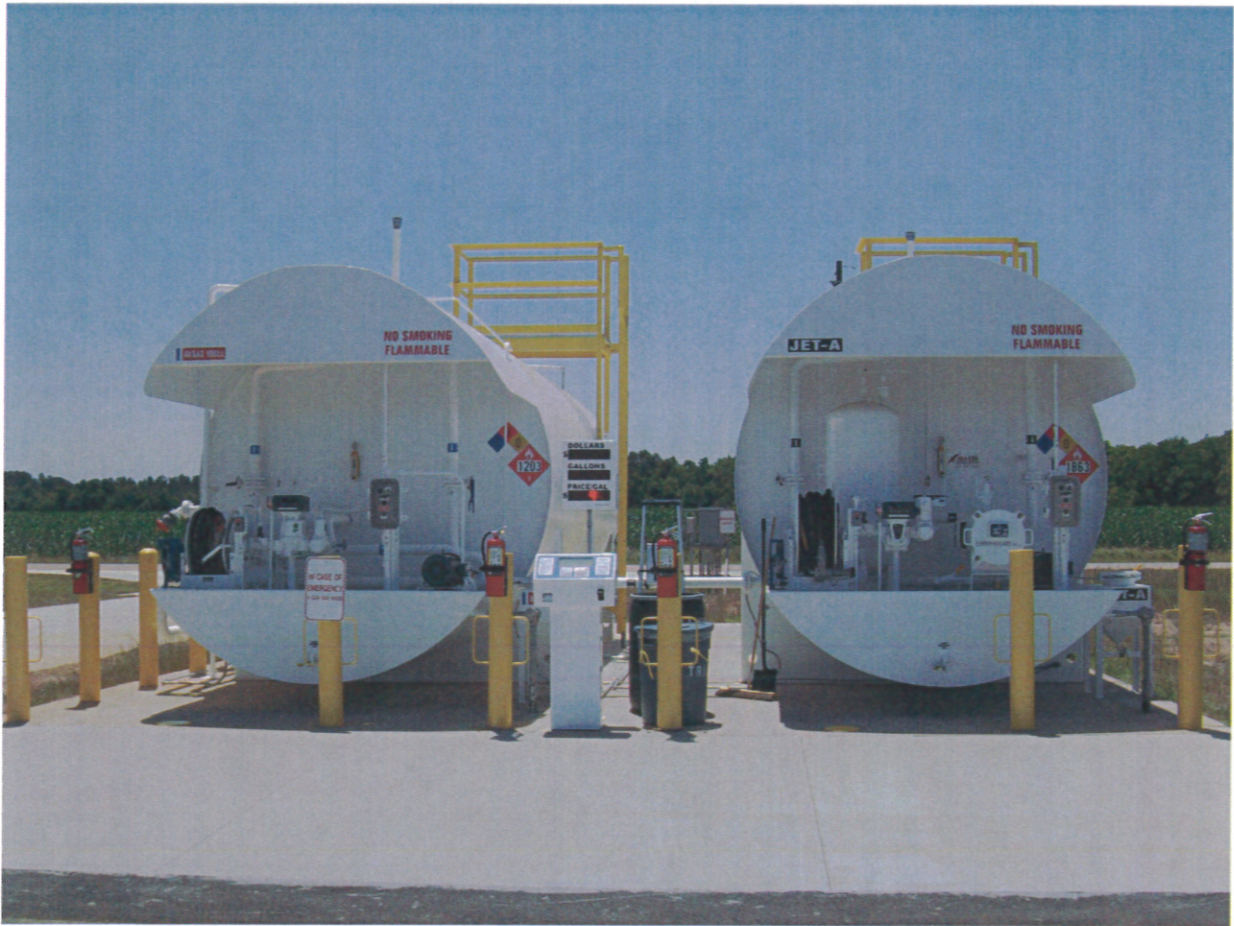
Photo # 7 – Jet-A and 100LL Fuel Service

- The fueling area meets the requirements established by the Alabama Department of Transportation. However, the State of Alabama Department of Agriculture and Industries may have additional requirements for fueling systems that were not considered during this inspection (See Photo # 7).
